**Flood Control Project Maintenance
Levee Inspections**
LMA District Cover Sheet
Spring 2014 Levee Inspection Results

San Joaquin County Flood Control and Water Conservation District

Spring 2014 Levee Inspection Results

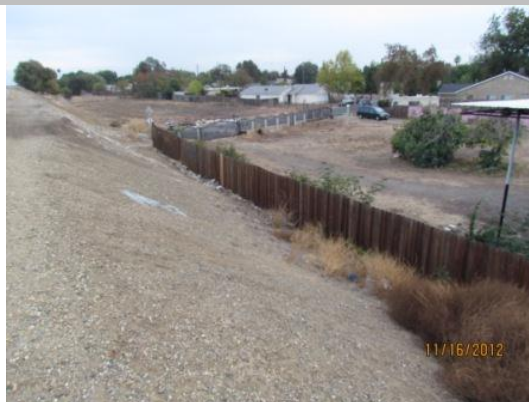
Photo 1 of 1 : pkazi_s_20140415_513.jpg

LM Start	17.57	Rating **	M	Issue No.	69
LM End	17.61	Issue Type +	En	Location *	LS
Category	Earthen Levee			GPS Latitude/Longitude	
				Start	End
Item	Encroachments			37.987313 °	37.987607 °
				-121.263725 °	-121.264392 °
DWR ID	DWR_NA0017_16_s_2012_69				
Action/Comments					
Fence

Fence was found on the landside toe of the levee looking upstream.

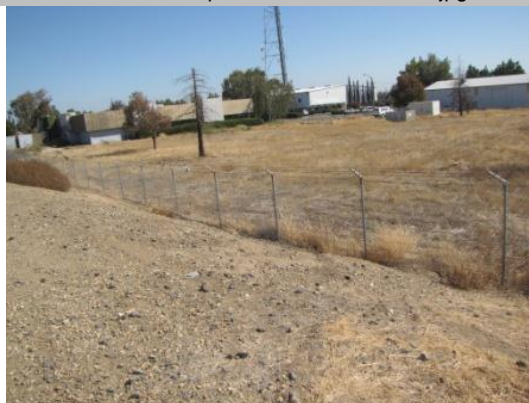
Photo 1 of 1 : pkazi_s_20140415_564.jpg

LM Start	19.00	Rating **	M	Issue No.	143
LM End	19.20	Issue Type +	En	Location *	LS
Category	Earthen Levee			GPS Latitude/Longitude	
				Start	End
Item	Encroachments			37.992385 °	37.992564 °
				-121.287251 °	-121.290846 °
DWR ID	DWR_NA0017_16_s_2012_143				
Action/Comments					
Fence

View of a fence along the landward toe looking upstream.

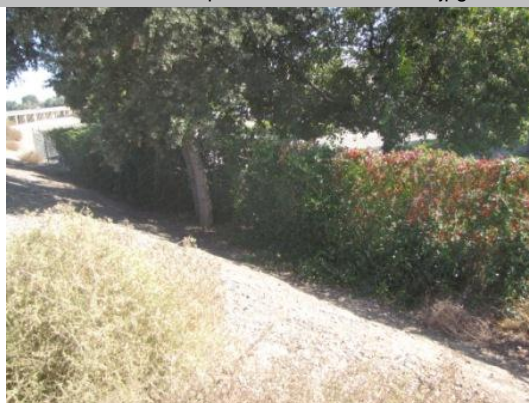
Photo 1 of 1 : pkazi_s_20140415_565.jpg

LM Start	19.12	Rating **	M	Issue No.	144
LM End	19.14	Issue Type +	En	Location *	LS
Category	Earthen Levee			GPS Latitude/Longitude	
				Start	End
Item	Vegetation			37.992834 °	37.992795 °
				-121.289403 °	-121.289685 °
DWR ID	DWR_NA0017_16_s_2012_144				
Action/Comments					
Landscaping

View of landscaping along the landward toe.

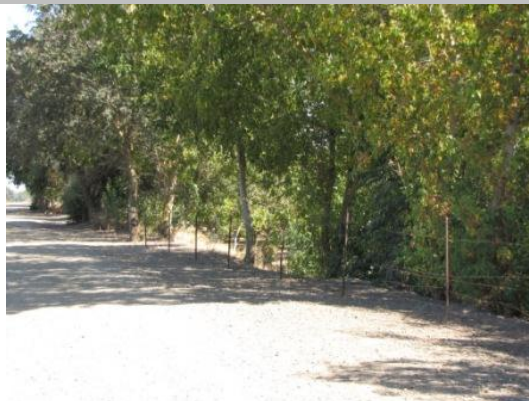
Photo 1 of 1 : pkazi_s_20140415_560.jpg

LM Start	19.47	Rating **	M	Issue No.	137
LM End	19.60	Issue Type +	En	Location *	LS
Category	Earthen Levee			GPS Latitude/Longitude	
				Start	End
Item	Encroachments			37.991653 °	37.991169 °
				-121.295441 °	-121.297768 °
DWR ID	DWR_NA0017_16_s_2012_137				
Action/Comments					
Fence					
Inspector Comments: Barbed wire

View of a barbed wire fence and landscaping along the landward shoulder and slope looking upstream.

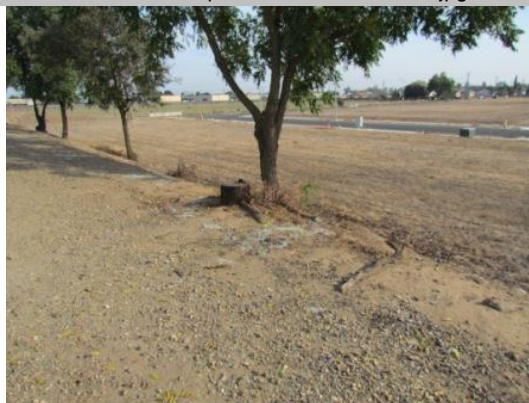
Photo 1 of 1 : pkazi_s_20140415_509.jpg

LM Start	19.48	Rating **	N	Issue No.	65
LM End	19.48	Issue Type +	Ma	Location *	LS
Category	Earthen Levee			GPS Latitude/Longitude	
				Start	End
Item	Trim / Thin Trees			37.991617 °	37.991617 °
				-121.295628 °	-121.295628 °
DWR ID	DWR_NA0017_16_s_2012_65				
Action/Comments					
Tree stumps.

Tree stump was found on the landside of the levee looking upstream.

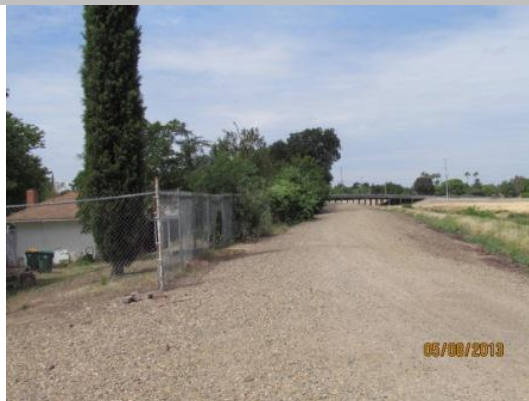
Photo 1 of 1 : pkazi_s_20140415_559.jpg

LM Start	19.60	Rating **	M	Issue No.	136
LM End	19.68	Issue Type +	En	Location *	LS
Category	Earthen Levee			GPS Latitude/Longitude	
				Start	End
Item	Vegetation			37.991204 °	37.991053 °
				-121.297757 °	-121.299231 °
DWR ID	DWR_NA0017_16_s_2012_136				
Action/Comments					
Landscaping

View of the landscaping on the landside shoulder of the levee looking downstream.

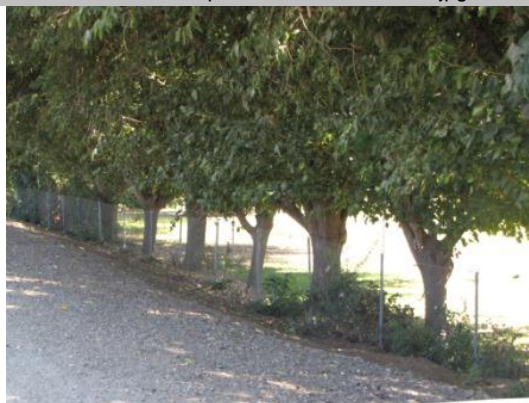
Photo 1 of 1 : pkazi_s_20140415_558.jpg

LM Start	19.60	Rating **	M	Issue No.	135
LM End	19.69	Issue Type +	En	Location *	LS
Category	Earthen Levee			GPS Latitude/Longitude	
				Start	End
Item	Encroachments			37.991171 °	37.991044 °
				-121.297767 °	-121.299334 °
DWR ID	DWR_NA0017_16_s_2012_135				
Action/Comments					
Fence

View of a fence along the landward slope looking upstream.

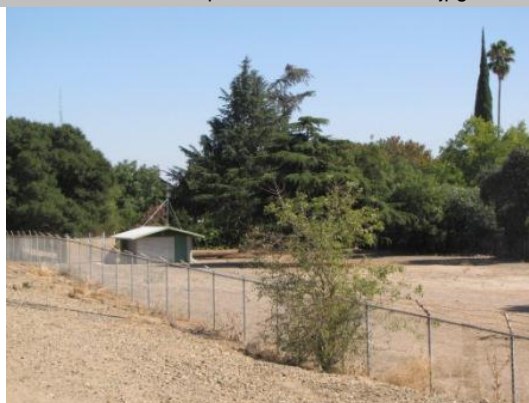
Photo 1 of 1 : pkazi_s_20140415_557.jpg

LM Start	19.82	Rating **	M	Issue No.	134
LM End	19.90	Issue Type +	En	Location *	LS
Category	Earthen Levee			GPS Latitude/Longitude	
				Start	End
Item	Encroachments			37.991130 °	37.990950 °
				-121.301742 °	-121.303084 °
DWR ID	DWR_NA0017_16_s_2012_134				
Action/Comments					
Fence

View of a fence along the landward toe looking upstream.

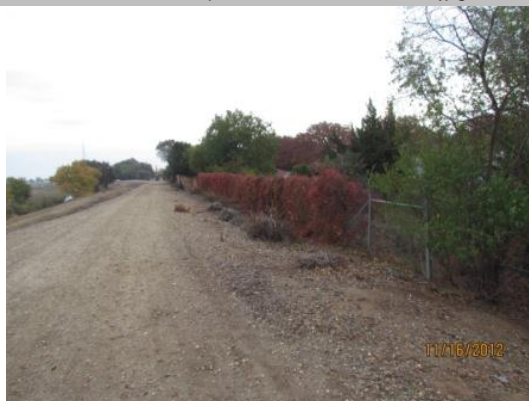
Photo 1 of 1 : pkazi_s_20140415_488.jpg

LM Start	19.83	Rating **	M	Issue No.	37
LM End	19.83	Issue Type +	En	Location *	LS
Category	Earthen Levee			GPS Latitude/Longitude	
				Start	End
Item	Vegetation			37.991127 °	37.991127 °
				-121.301817 °	-121.301817 °
DWR ID	DWR_NA0017_16_f_2012_37				
Action/Comments					
Landscaping

Landscaping was found on the landside shoulder of the levee looking upstream.

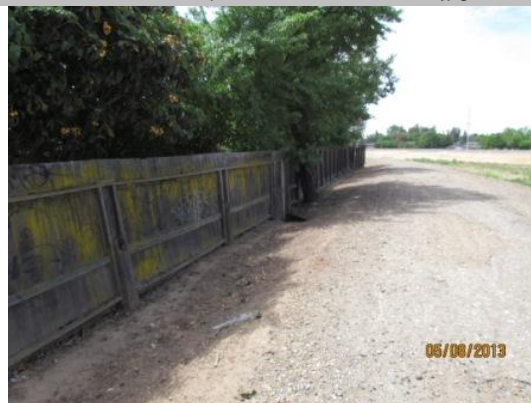
Photo 1 of 1 : pkazi_s_20140415_519.jpg

LM Start	20.04	Rating **	U	Issue No.	78
LM End	20.04	Issue Type +	En	Location *	LS
Category	Earthen Levee			GPS Latitude/Longitude	
				Start	End
Item	Encroachments			37.989681 °	37.989681 °
				-121.305221 °	-121.305221 °
DWR ID	DWR_NA0017_16_s_2012_78				
Action/Comments					
Fence

Fences were obstructing the landside slope of the levee looking downstream.

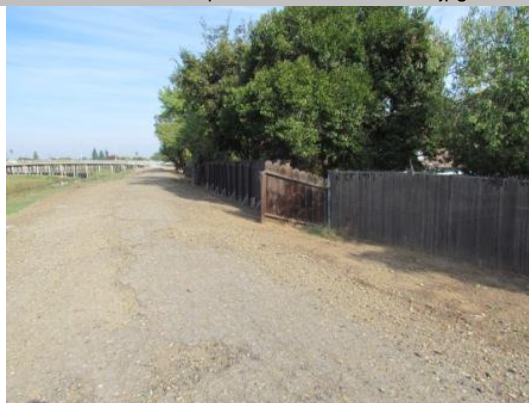
Photo 1 of 1 : pkazi_s_20140415_487.jpg

LM Start	20.05	Rating **	M	Issue No.	36
LM End	20.05	Issue Type +	En	Location *	LS
Category	Earthen Levee			GPS Latitude/Longitude	
				Start	End
Item	Encroachments			37.989382 °	37.989382 °
				-121.305158 °	-121.305158 °
DWR ID	DWR_NA0017_16_s_2012_36				
Action/Comments					
Fence

Wooden fence on the landside of the levee looking upstream.

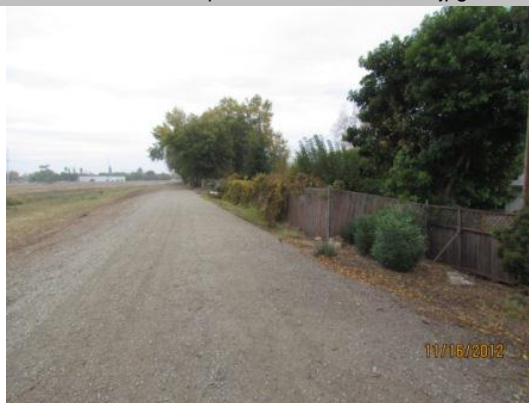
Photo 1 of 1 : pkazi_s_20140415_485.jpg

LM Start	20.23	Rating **	U	Issue No.	27
LM End	20.23	Issue Type +	En	Location *	LS
Category	Earthen Levee			GPS Latitude/Longitude	
				Start	End
Item	Encroachments			37.987093 °	37.987093 °
				-121.306495 °	-121.306495 °
DWR ID	DWR_NA0017_16_s_2012_27				
Action/Comments					
Fence

A fence was found on the landside shoulder of the levee looking upstream.

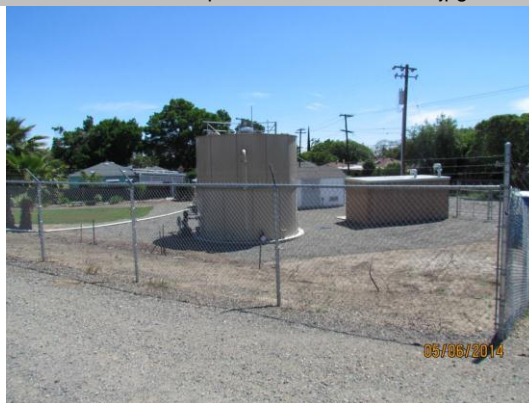
Photo 1 of 2 : pkazi_s_20140512_962.jpg

LM Start	20.26	Rating **	M	Issue No.	161
LM End	20.26	Issue Type +	En	Location *	LS
Category	Earthen Levee			GPS Latitude/Longitude	
				Start	End
Item	Encroachments			37.986848 °	37.986848 °
				-121.306716 °	-121.306716 °
DWR ID	DWR_NA0017_16_s_2013_161				
Action/Comments					
Tank					
Inspector Comments: An unpermitted tank was found on the landside toe of the levee.

View of the tank (unpermitted) on the landside toe of the levee looking upstream.

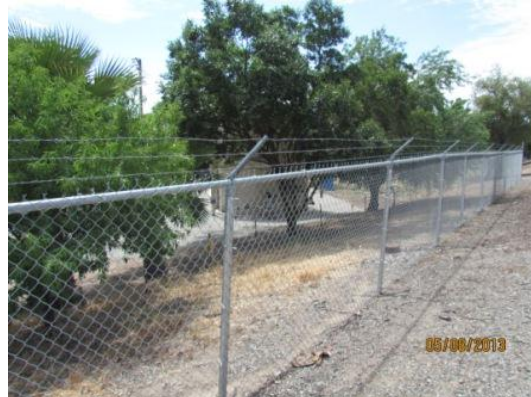
Photo 2 of 2 : pkazi_s_20140415_581.jpg

LM Start	20.26	Rating **	M	Issue No.	161 (cont)
LM End	20.26	Issue Type +	En	Location *	LS
Category	Earthen Levee			GPS Latitude/Longitude	
				Start	End
Item	Encroachments			37.986848 °	37.986848 °
				-121.306716 °	-121.306716 °
DWR ID	DWR_NA0017_16_s_2013_161				
Action/Comments					
Tank					
Inspector Comments: An unpermitted tank was found on the landside toe of the levee.

A newly installed tank (unpermitted) was found on the landside toe of the levee looking downstream.

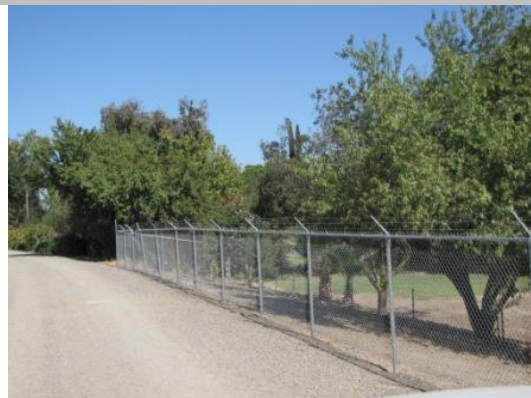
Photo 1 of 1 : pkazi_s_20140415_555.jpg

LM Start	20.26	Rating **	M	Issue No.	132
LM End	20.28	Issue Type +	En	Location *	LS
Category	Earthen Levee			GPS Latitude/Longitude	
				Start	End
Item	Encroachments			37.986906 °	37.986619 °
				-121.306688 °	-121.306892 °
DWR ID	DWR_NA0017_16_s_2012_132				
Action/Comments					
Fence

View of a fence along the landward slope looking upstream.

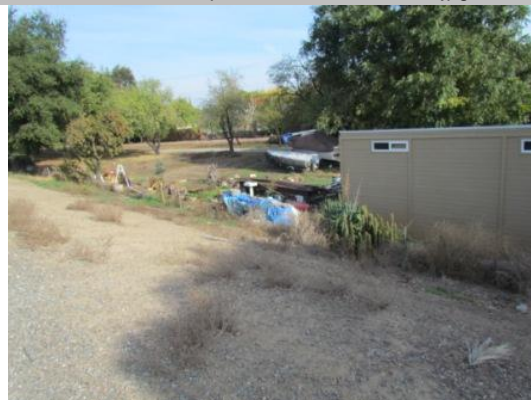
Photo 1 of 1 : pkazi_s_20140415_597.jpg

LM Start	20.45	Rating **	M	Issue No.	178
LM End	20.48	Issue Type +	En	Location *	LS
Category	Earthen Levee			GPS Latitude/Longitude	
				Start	End
Item	Vegetation			37.984576 °	37.984215 °
				-121.308320 °	-121.308818 °
DWR ID	DWR_NA0017_16_s_2012_178				
Action/Comments					
Landscaping

Landscaping was found on the toe of landside of the levee looking upstream.

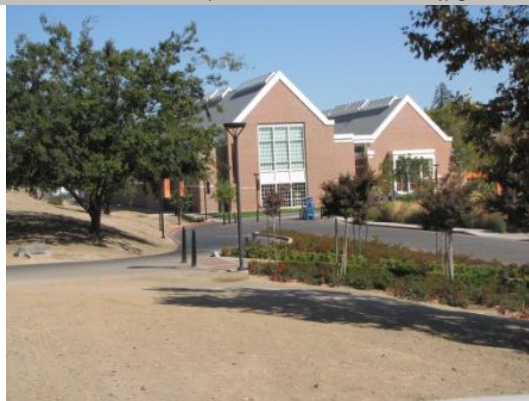
Photo 1 of 1 : pkazi_s_20140415_553.jpg

LM Start	20.83	Rating **	M	Issue No.	130
LM End	20.83	Issue Type +	En	Location *	LS
Category	Earthen Levee			GPS Latitude/Longitude	
				Start	End
Item	Vegetation			37.980958 °	37.980958 °
				-121.313596 °	-121.313596 °
DWR ID	DWR_NA0017_16_s_2012_130				
Action/Comments					
Landscaping

View of landscaping planted and maintained by UOP along the landward slope and toe looking upstream.

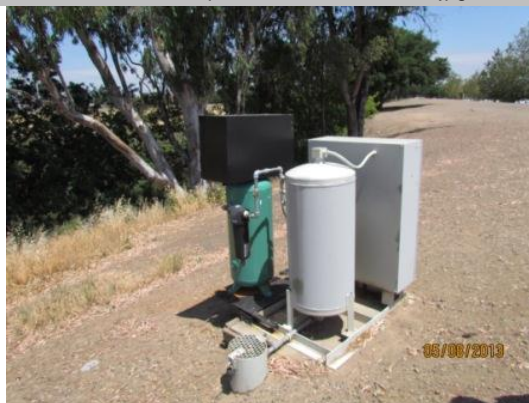
Photo 1 of 1 : pkazi_s_20140415_594.jpg

LM Start	20.97	Rating **	M	Issue No.	174
LM End	20.97	Issue Type +	En	Location *	WS
Category	Earthen Levee			GPS Latitude/Longitude	
				Start	End
Item	Encroachments			37.979679 °	37.979679 °
				-121.315359 °	-121.315359 °
DWR ID	DWR_NA0017_16_s_2013_174				
Action/Comments					
Tank					
Inspector Comments: It appears to be a compressor on the waterside shoulder of the levee.

A compressor was found on the waterside shoulder of the levee looking upstream.

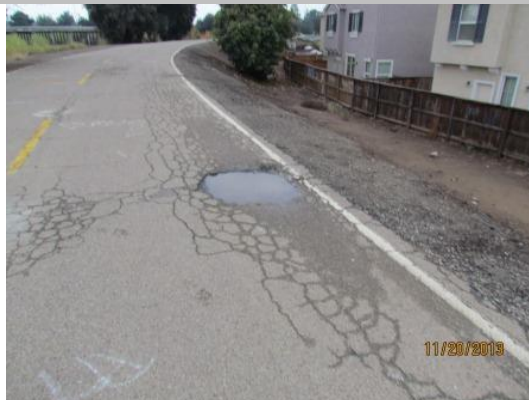
Photo 1 of 1 : pkazi_s_20140415_523.jpg

LM Start	21.31	Rating **	M	Issue No.	86
LM End	21.31	Issue Type +	Ma	Location *	CR
Category	Earthen Levee			GPS Latitude/Longitude	
				Start	End
Item	Crown Surface / Depressions / Rutting			37.980156 °	37.980156 °
				-121.320615 °	-121.320615 °
DWR ID	DWR_NA0017_16_f_2013_86				
Action/Comments					
Add appropriate material and re-grade the levee to bring the crown above the design elevation.

Crown depression was found on the levee looking upstream.

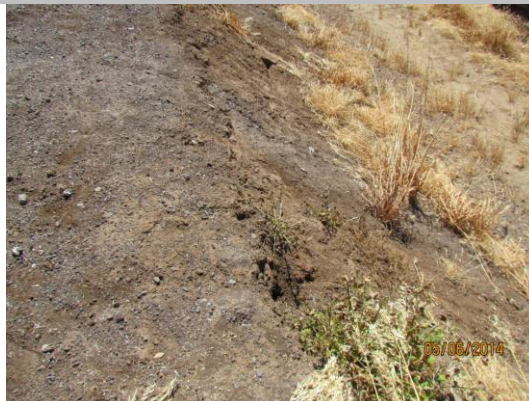
Photo 1 of 2 : pkazi_s_20140512_961.jpg

LM Start	21.31	Rating **	M	Issue No.	83
LM End	21.31	Issue Type +	Ma	Location *	LS
Category	Earthen Levee			GPS Latitude/Longitude	
				Start	End
Item	Animal Control			37.980192 °	37.980192 °
				-121.320720 °	-121.320720 °
DWR ID	DWR_NA0017_16_f_2013_83				
Action/Comments					
No rodents visible, but rodent burrows visible; need to backfill and compact or grout burrows.

View of rodent holes on the landside of the levee looking upstream during spring 2014 inspection.

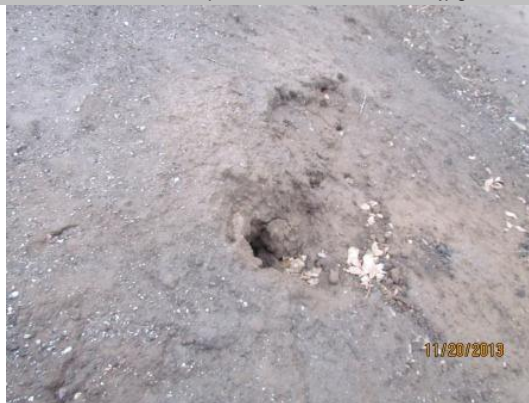
Photo 2 of 2 : pkazi_s_20140415_522.jpg

LM Start	21.31	Rating **	M	Issue No.	83 (cont)
LM End	21.31	Issue Type +	Ma	Location *	LS

A rodent hole was found on the landside of the levee looking upstream.

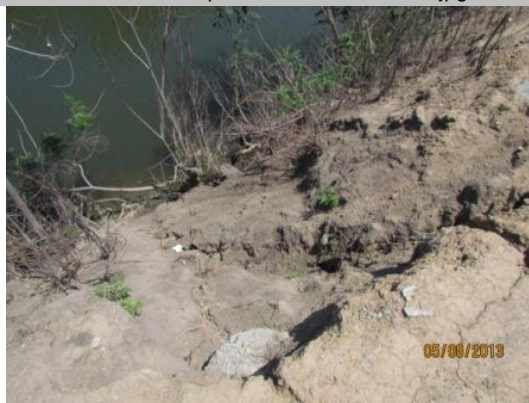
Photo 1 of 1 : pkazi_s_20140415_595.jpg

LM Start	21.37	Rating **	M	Issue No.	175
LM End	21.37	Issue Type +	Ma	Location *	WS
Category	Earthen Levee			GPS Latitude/Longitude	
				Start	End
Item	Erosion / Bank Caving			37.980477 °	37.980477 °
				-121.321656 °	-121.321656 °
DWR ID	DWR_NA0017_16_s _ 2013_175				
Action/Comments					
Schedule repair of erosion site prior to the next inspection.

Slope instability was found on the waterside slope of the levee looking upstream.

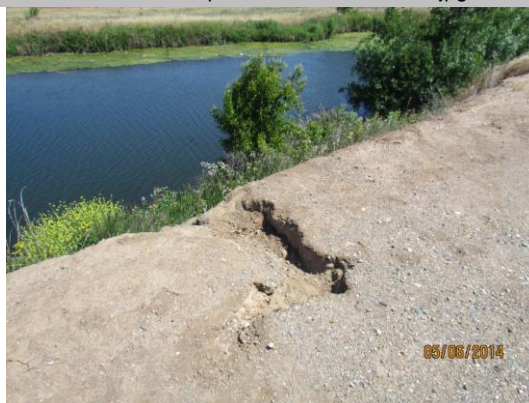
Photo 1 of 2 : pkazi_s_20140512_960.jpg

LM Start	21.44	Rating **	M	Issue No.	197
LM End	21.44	Issue Type +	Ma	Location *	WS
Category	Earthen Levee			GPS Latitude/Longitude	
				Start	End
Item	Erosion / Bank Caving			37.980569 °	37.980569 °
				-121.322985 °	-121.322985 °
DWR ID	DWR_NA0017_16_s _ 2013_197				
Action/Comments					
Schedule repair of erosion site prior to the next inspection.

updated picture of the erosion on the waterside of the levee looking upstream during spring 2014 inspection.

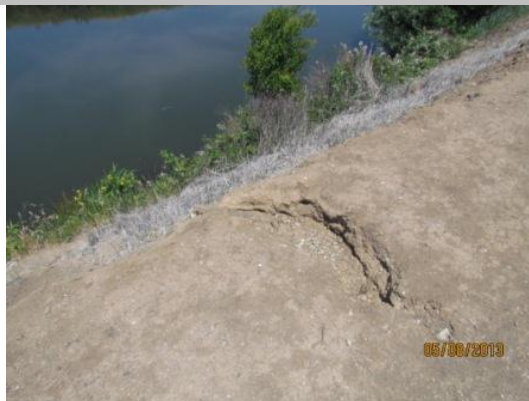
Photo 2 of 2 : pkazi_s_20140415_604.jpg

Erosion was found on the waterside slope of the levee looking upstream.

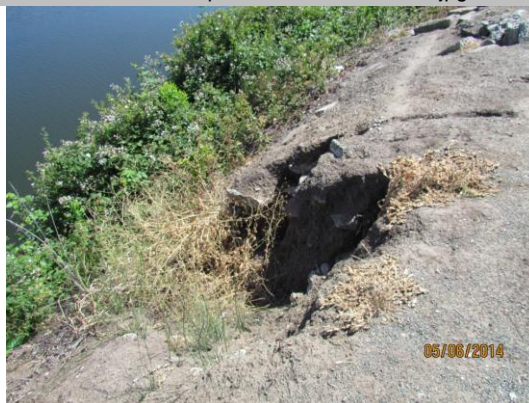
Photo 1 of 2 : pkazi_s_20140512_959.jpg

LM Start	21.52	Rating **	M	Issue No.	82
LM End	21.52	Issue Type +	Ma	Location *	WS
Category	Earthen Levee			GPS Latitude/Longitude	
				Start	End
Item	Erosion / Bank Caving			37.980845 °	37.980845 °
				-121.324241 °	-121.324241 °
DWR ID	DWR_NA0017_16_f_2013_82				
Action/Comments					
Schedule repair of erosion site prior to the next inspection.

Updated picture of erosion on the waterside of the levee looking upstream during spring 2014 inspection.

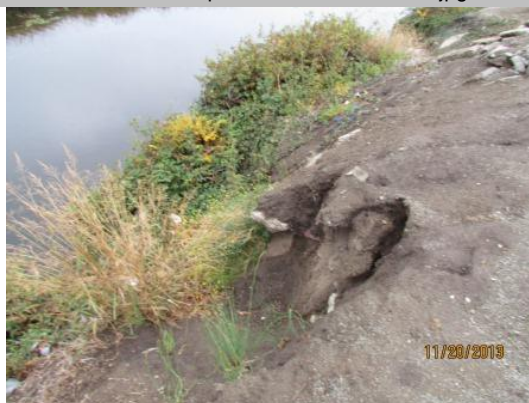
Photo 2 of 2 : pkazi_s_20140415_521.jpg

Erosion was found on the waterside of the levee looking upstream.

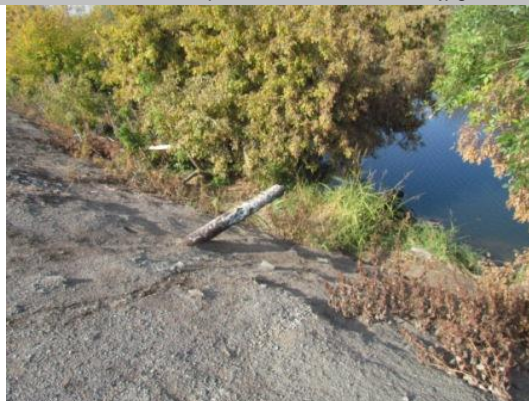
Photo 1 of 1 : pkazi_s_20140415_628.jpg

LM Start	21.54	Rating **	M	Issue No.	761
LM End	21.54	Issue Type +	Ma	Location *	WS
Category	Earthen Levee			GPS Latitude/Longitude	
				Start	End
Item	Encroachments				°
					°
DWR ID	DWR_NA0017_16_s_2012_761				
Action/Comments					
Pipe

An abandoned pipe was found on the waterside of the levee looking downstream.

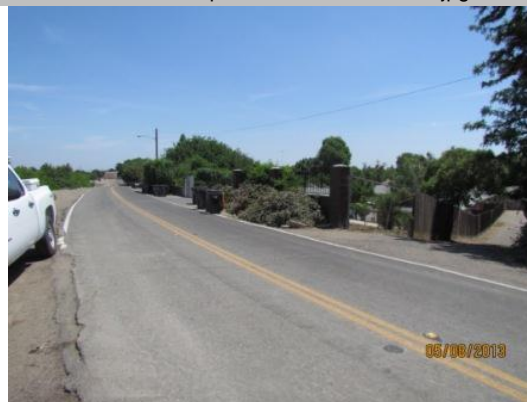
Photo 1 of 1 : pkazi_s_20140415_483.jpg

LM Start	21.64	Rating **	M	Issue No.	21
LM End	21.64	Issue Type +	En	Location *	LS
Category	Earthen Levee			GPS Latitude/Longitude	
				Start	End
Item	Vegetation			37.981132 °	37.981132 °
				-121.326753 °	-121.326753 °
DWR ID	DWR_NA0017_16_s_2012_21				
Action/Comments					
Landscaping

Landscaping was found on the landside of the levee looking upstream.

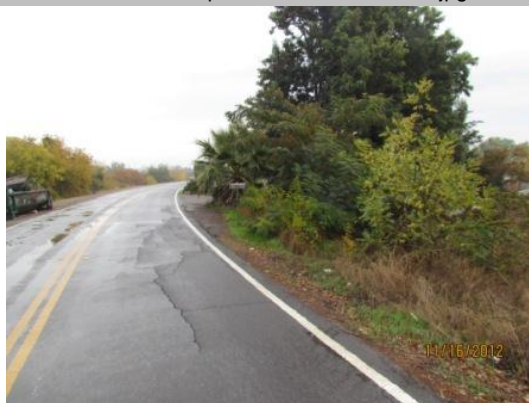
Photo 1 of 1 : pkazi_s_20140415_482.jpg

LM Start	21.71	Rating **	M	Issue No.	20
LM End	21.71	Issue Type +	En	Location *	LS
Category	Earthen Levee			GPS Latitude/Longitude	
				Start	End
Item	Vegetation			37.981185 °	37.981185 °
				-121.327822 °	-121.327822 °
DWR ID	DWR_NA0017_16_s_2012_20				
Action/Comments					
Landscaping

Landscaping was found on the landside shoulder of the levee looking upstream.

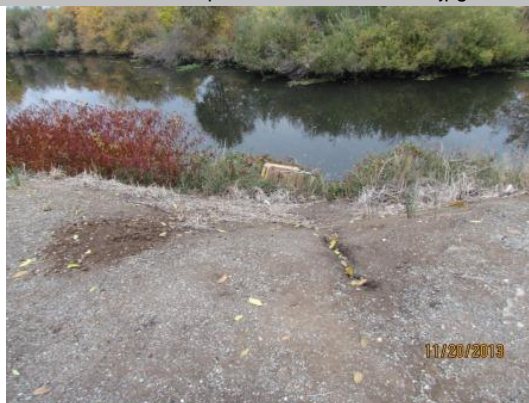
Photo 1 of 1 : pkazi_s_20140415_517.jpg

LM Start	21.78	Rating **	M	Issue No.	74
LM End	21.78	Issue Type +	Ma	Location *	WS
Category	Earthen Levee			GPS Latitude/Longitude	
				Start	End
Item	Erosion / Bank Caving			37.980773 °	37.980773 °
				-121.328866 °	-121.328866 °
DWR ID	DWR_NA0017_16_f_2013_74				
Action/Comments					
Schedule repair of erosion site prior to the next inspection. Inspector Comments: Runoff

Erosion due to runoff was found on the waterside of the levee looking upstream.

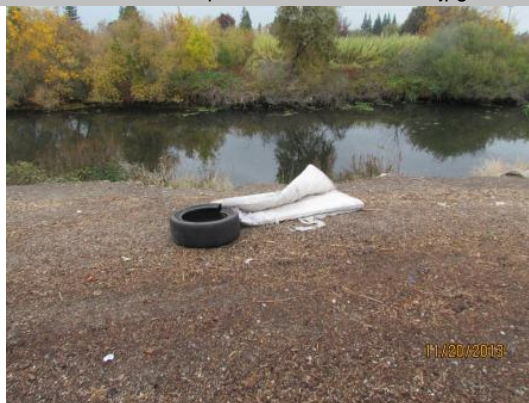
Photo 1 of 1 : pkazi_s_20140415_514.jpg

LM Start	21.83	Rating **	M	Issue No.	70
LM End	21.83	Issue Type +	Ma	Location *	WS
Category	Earthen Levee			GPS Latitude/Longitude	
				Start	End
Item	Encroachments			37.980543 °	37.980543 °
				-121.329590 °	-121.329590 °
DWR ID	DWR_NA0017_16_f_2013_70				
Action/Comments					
Debris

Debris was found on the waterside shoulder of the levee looking upstream.

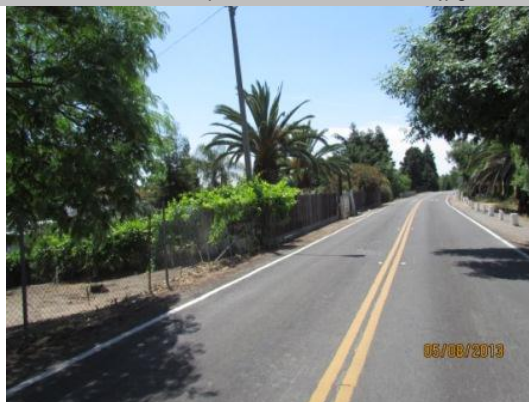
Photo 1 of 1 : pkazi_s_20140415_480.jpg

LM Start	21.90	Rating **	M	Issue No.	15
LM End	21.90	Issue Type +	En	Location *	WS
Category	Earthen Levee			GPS Latitude/Longitude	
				Start	End
Item	Vegetation			37.980042 °	37.980042 °
				-121.330953 °	-121.330953 °
DWR ID	DWR_NA0017_16_s_2012_15				
Action/Comments					
Landscaping

Landscaping was found on the landside of the levee looking downstream.

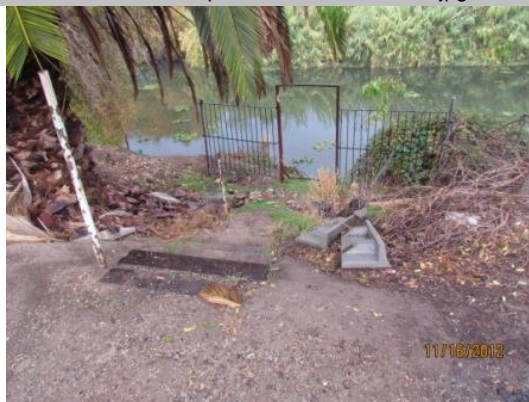
Photo 1 of 1 : pkazi_s_20140415_474.jpg

LM Start	21.91	Rating **	M	Issue No.	9
LM End	21.91	Issue Type +	En	Location *	WS
Category	Earthen Levee			GPS Latitude/Longitude	
				Start	End
Item	Encroachments			37.980147 °	37.980147 °
				-121.330945 °	-121.330945 °
DWR ID	DWR_NA0017_16_f_2012_9				
Action/Comments					
Stairway

Stairs and fence were located on the waterside slope of the levee looking downstream.

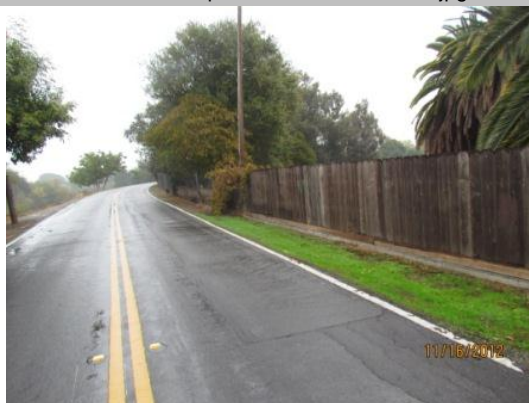
Photo 1 of 1 : pkazi_s_20140415_477.jpg

LM Start	21.91	Rating **	U	Issue No.	12
LM End	21.91	Issue Type +	En	Location *	LS
Category	Earthen Levee			GPS Latitude/Longitude	
				Start	End
Item	Encroachments			37.980147 °	37.980147 °
				-121.330947 °	-121.330947 °
DWR ID	DWR_NA0017_16_f_2012_12				
Action/Comments					
Fence

A fence was found on the landside shoulder of the levee looking upstream.

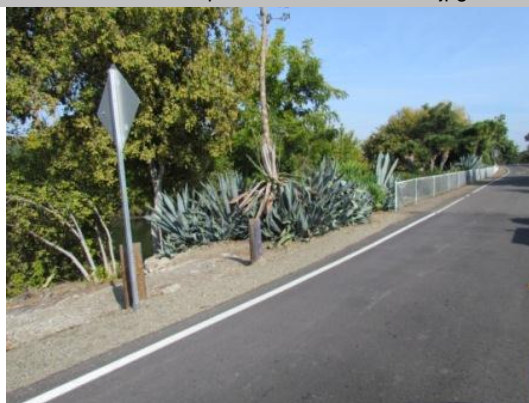
Photo 1 of 1 : pkazi_s_20140415_476.jpg

LM Start	21.97	Rating **	M	Issue No.	11
LM End	21.97	Issue Type +	En	Location *	WS
Category	Earthen Levee			GPS Latitude/Longitude	
				Start	End
Item	Vegetation			37.979652 °	37.979652 °
				-121.332265 °	-121.332265 °
DWR ID	DWR_NA0017_16_s_2012_11				
Action/Comments					
Landscaping

View of landscaping on the waterside of the levee looking upstream.

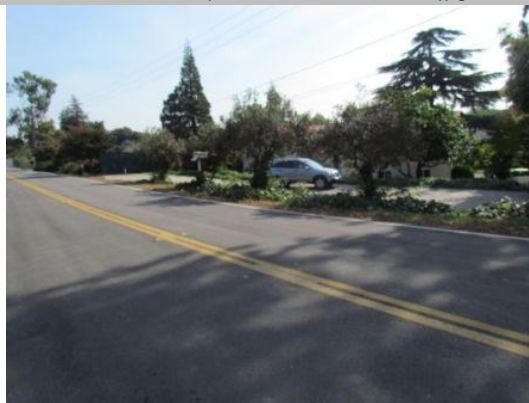
Photo 1 of 1 : pkazi_s_20140415_473.jpg

LM Start	22.08	Rating **	M	Issue No.	8
LM End	22.08	Issue Type +	En	Location *	LS
Category	Earthen Levee			GPS Latitude/Longitude	
				Start	End
Item	Vegetation			37.979820 °	37.979820 °
				-121.334107 °	-121.334107 °
DWR ID	DWR_NA0017_16_s_2012_8				
Action/Comments					
Landscaping

View of the landscape on the landside of the levee looking upstream.

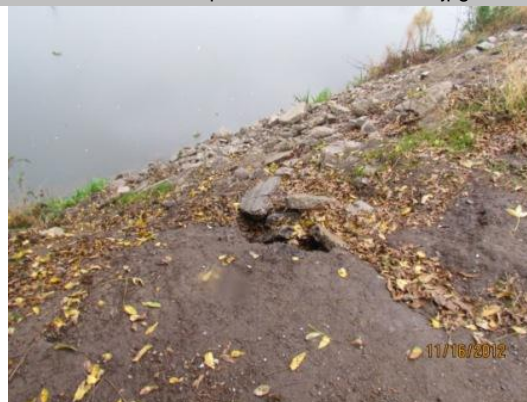
Photo 1 of 1 : pkazi_s_20140415_512.jpg

LM Start	22.15	Rating **	M	Issue No.	68
LM End	22.15	Issue Type +	Ma	Location *	WS
Category	Earthen Levee			GPS Latitude/Longitude	
				Start	End
Item	Erosion / Bank Caving			37.979674 °	37.979674 °
				-121.335228 °	-121.335228 °
DWR ID	DWR_NA0017_16_f_2012_68				
Action/Comments					
Schedule repair of erosion site prior to the next inspection.

Erosion was found on the waterside slope of the levee looking upstream.

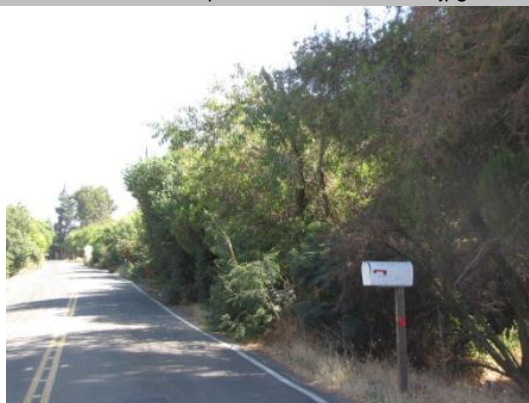
Photo 1 of 1 : pkazi_s_20140415_545.jpg

LM Start	22.17	Rating **	M	Issue No.	118
LM End	22.37	Issue Type +	En	Location *	LS
Category	Earthen Levee			GPS Latitude/Longitude	
				Start	End
Item	Vegetation			37.979630 °	37.979450 °
				-121.335440 °	-121.339030 °
DWR ID	DWR_NA0017_16_s_2012_118				
Action/Comments					
Landscaping

View of landscaping along landward slope looking upstream.

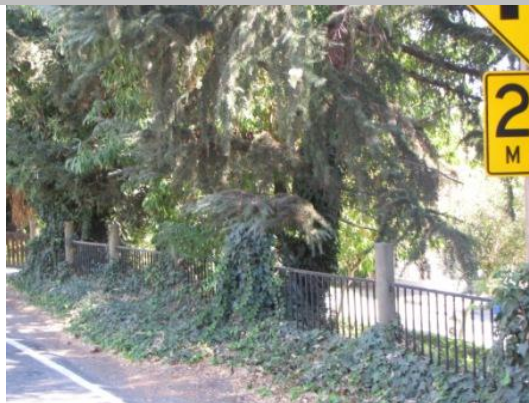
Photo 1 of 1 : pkazi_s_20140415_548.jpg

LM Start	22.17	Rating **	M	Issue No.	124
LM End	22.18	Issue Type +	En	Location *	LS
Category	Earthen Levee			GPS Latitude/Longitude	
				Start	End
Item	Encroachments			37.979622 °	37.979570 °
				-121.335440 °	-121.335620 °
DWR ID	DWR_NA0017_16_s_2012_124				
Action/Comments					
Fence					
Inspector Comments: Metal open fence

View of a fence and landscaping along the landward shoulder and slope looking upstream.

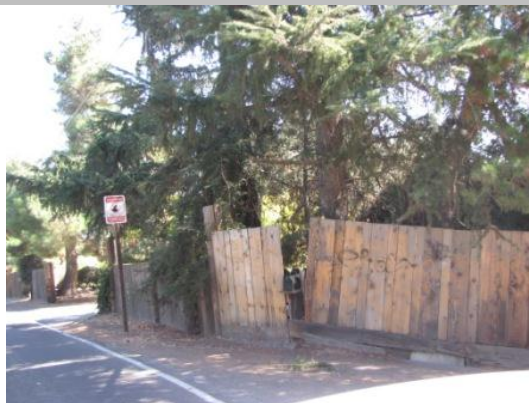
Photo 1 of 1 : pkazi_s_20140415_547.jpg

LM Start	22.19	Rating **	U	Issue No.	123
LM End	22.21	Issue Type +	En	Location *	LS
Category	Earthen Levee			GPS Latitude/Longitude	
				Start	End
Item	Encroachments			37.979453 °	37.979400 °
				-121.335830 °	-121.336337 °
DWR ID	DWR_NA0017_16_s_2012_123				
Action/Comments					
Fence					
Inspector Comments: Solid wood fence

View of a fence along the landward shoulder and slope looking upstream.

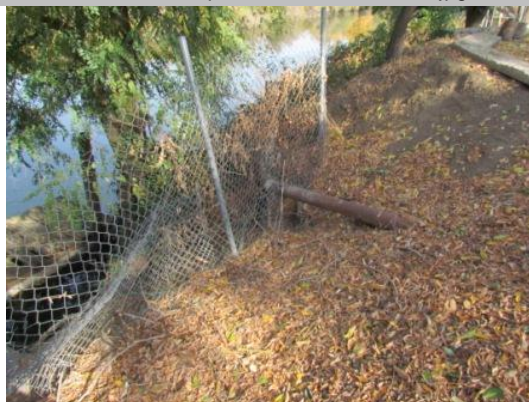
Photo 1 of 2 : pkazi_s_20140415_541.jpg

LM Start	22.21	Rating **	M	Issue No.	115
LM End	22.21	Issue Type +	En	Location *	WS
Category	Earthen Levee			GPS Latitude/Longitude	
				Start	End
Item	Encroachments				°
					°
DWR ID	DWR_NA0017_16_s _ 2012_115				
Action/Comments					
Pipe Inspector Comments: Abandoned pipe was found on the waterside shoulder of the levee.

An unpermitted abandoned pipe was found with electrical wires running through it on the waterside shoulder of the levee looking upstream.

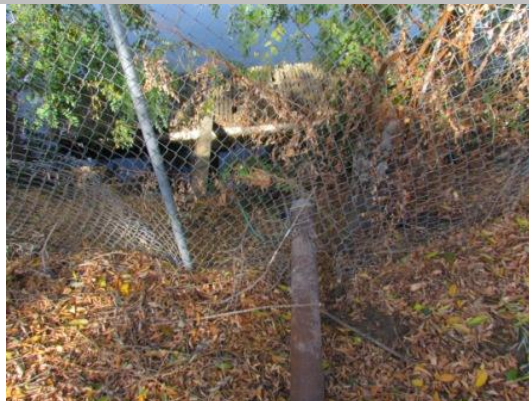
Photo 2 of 2 : pkazi_s_20140415_542.jpg

View of the electrical wires through the pipe is found on the waterside of the levee. The picture was taken from the crown looking towards the toe of the levee.

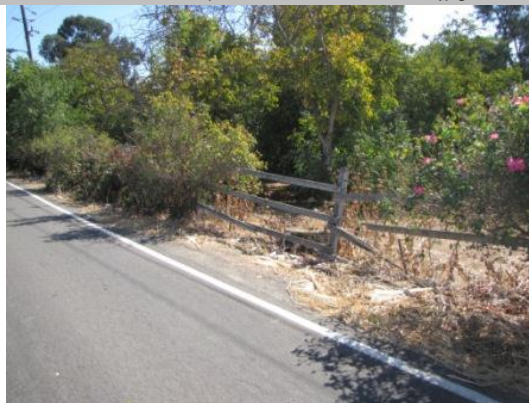
Photo 1 of 1 : pkazi_s_20140415_546.jpg

LM Start	22.26	Rating **	M	Issue No.	121
LM End	22.30	Issue Type +	En	Location *	LS
Category	Earthen Levee			GPS Latitude/Longitude	
				Start	End
Item	Encroachments			37.979391 °	37.979404 °
				-121.337067 °	-121.337784 °
DWR ID	DWR_NA0017_16_s_2012_121				
Action/Comments					
Fence

View of a fence along the landward shoulder looking upstream.

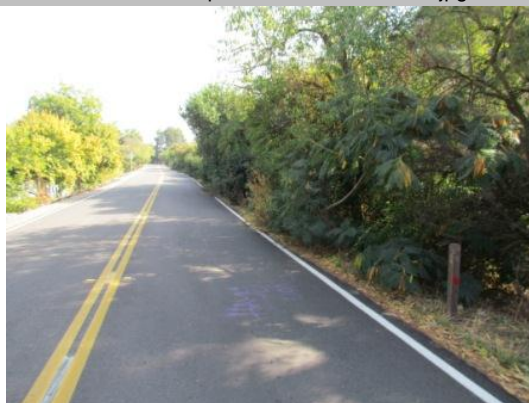
Photo 1 of 1 : pkazi_s_20140415_510.jpg

LM Start	22.27	Rating **	M	Issue No.	66
LM End	22.28	Issue Type +	En	Location *	LS
Category	Earthen Levee			GPS Latitude/Longitude	
				Start	End
Item	Vegetation			37.979393 °	37.979401 °
				-121.337241 °	-121.337502 °
DWR ID	DWR_NA0017_16_s_2012_66				
Action/Comments					
Landscaping

Landscaping was found on the landside of the levee looking upstream.

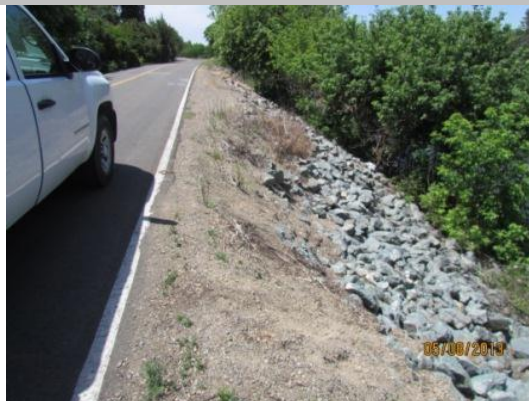
Photo 1 of 1 : pkazi_s_20140415_606.jpg

LM Start	22.30	Rating **	M	Issue No.	203
LM End	22.30	Issue Type +	Ma	Location *	WS
Category	Earthen Levee			GPS Latitude/Longitude	
				Start	End
Item	Slope Stability			37.979412 °	37.979412 °
				-121.337810 °	-121.337810 °
DWR ID	DWR_NA0017_16_s_2013_203				
Action/Comments					
Repair slope instability.

Slope instability was found on the waterside slope of the levee looking downstream.

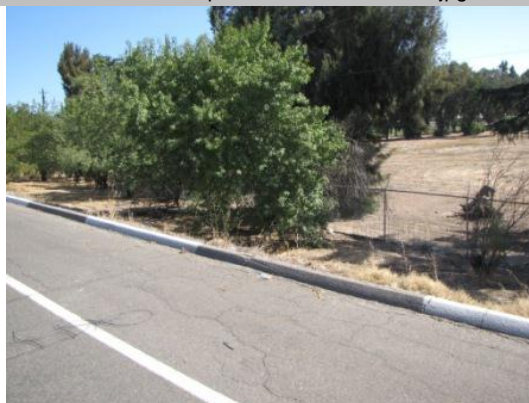
Photo 1 of 1 : pkazi_s_20140415_544.jpg

LM Start	22.37	Rating **	M	Issue No.	117
LM End	22.43	Issue Type +	En	Location *	LS
Category	Earthen Levee			GPS Latitude/Longitude	
				Start	End
Item	Encroachments			37.979454 °	37.979138 °
				-121.339031 °	-121.340034 °
DWR ID	DWR_NA0017_16_s_2012_117				
Action/Comments					
Fence

View of fence and landscaping along landward slope looking upstream.

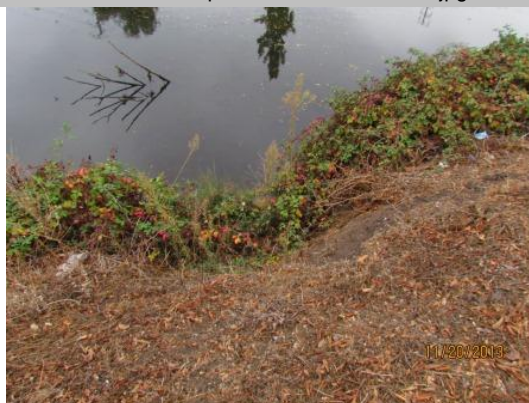
Photo 1 of 1 : pkazi_s_20140415_507.jpg

LM Start	22.41	Rating **	M	Issue No.	62
LM End	22.41	Issue Type +	Ma	Location *	WS
Category	Earthen Levee			GPS Latitude/Longitude	
				Start	End
Item	Erosion / Bank Caving			37.979251 °	37.979251 °
				-121.340012 °	-121.340012 °
DWR ID	DWR_NA0017_16_f_2013_62				
Action/Comments					
Schedule repair of erosion site prior to the next inspection.

Erosion was found on the waterside slope of the levee looking upstream.

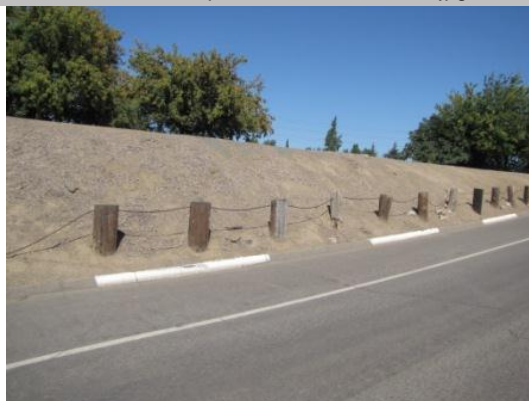
Photo 1 of 1 : pkazi_s_20140415_543.jpg

LM Start	22.43	Rating **	M	Issue No.	116
LM End	22.46	Issue Type +	En	Location *	LS
Category	Earthen Levee			GPS Latitude/Longitude	
				Start	End
Item	Encroachments			37.979094 °	37.978845 °
				-121.340095 °	-121.340572 °
DWR ID	DWR_NA0017_16_s_2012_116				
Action/Comments					
Fence Inspector Comments: Post and cable fence

View of a post and cable fence along the landward slope looking upstream.

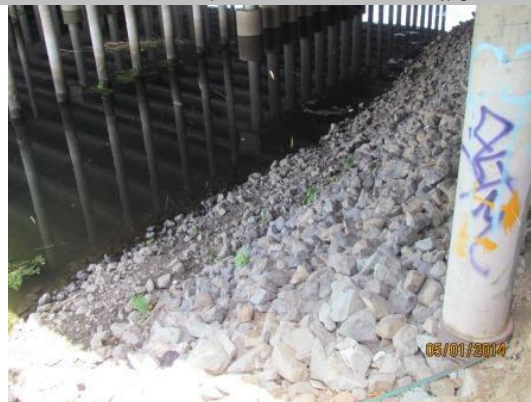
Photo 2 of 6 : pkazi_s_20140505_954.jpg

LM Start	22.52	Rating **	U	Issue No.	48
LM End	22.52	Issue Type +	Ma	Location *	WS
Category	Earthen Levee			GPS Latitude/Longitude	
				Start	End
Item	Erosion / Bank Caving			37.978697 °	37.978697 °
				-121.341581 °	-121.341581 °
DWR ID	DWR_NA0017_16_s_2012_48				
Action/Comments					
Schedule repair of erosion site prior to the next inspection. Inspector Comments: Waterward bank damaged under I-5 and shows significant erosion. Currently, Caltrans is repairing the issue. (Permit # 18532)

Updated picture of the erosion under the (I-5) bridge done by Caltrans. The picture was taken from the crown of the levee during spring 2014 inspection.

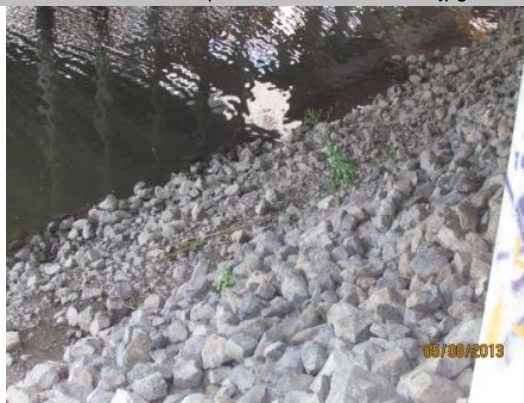
Photo 3 of 6 : pkazi_s_20140415_496.jpg

LM Start	22.52	Rating **	U	Issue No.	48 (cont)
LM End	22.52	Issue Type +	Ma	Location *	WS
Category	Earthen Levee			GPS Latitude/Longitude	
				Start	End
Item	Erosion / Bank Caving			37.978697 °	37.978697 °
				-121.341581 °	-121.341581 °
DWR ID	DWR_NA0017_16_s_2012_48				
Action/Comments					
Schedule repair of erosion site prior to the next inspection.

Updated view of the erosion site over the I-5 bridge (southbound) repaired by Caltrans. This picture was taken from the crown of the levee looking upstream during spring 2013 inspection.

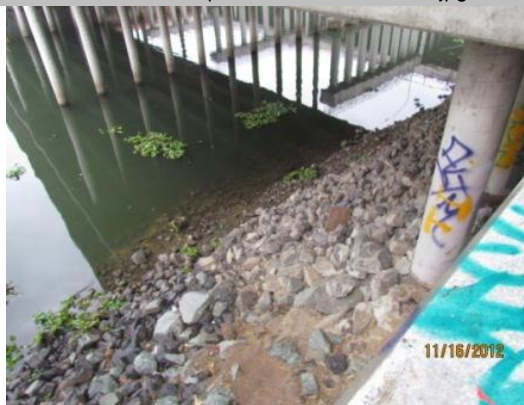
Photo 4 of 6 : pkazi_s_20140415_495.jpg

LM Start	22.52	Rating **	U	Issue No.	48 (cont)
LM End	22.52	Issue Type +	Ma	Location *	WS

Updated view of the erosion site repaired by Caltrans on the waterside slope of the levee looking upstream.

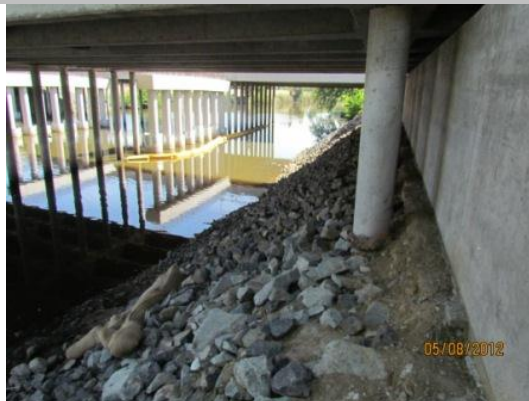
Photo 5 of 6 : pkazi_s_20140415_494.jpg

LM Start	22.52	Rating **	U	Issue No.	48 (cont)
LM End	22.52	Issue Type +	Ma	Location *	WS
Category	Earthen Levee			GPS Latitude/Longitude	
				Start	End
Item	Erosion / Bank Caving			37.978697 °	37.978697 °
				-121.341581 °	-121.341581 °
DWR ID	DWR_NA0017_16_s _ 2012_48				
Action/Comments					
Schedule repair of erosion site prior to the next inspection.

View of the erosion site repaired by Caltrans under the I-5 freeway going southbound. This picture was taken from the toe of the levee looking upstream.

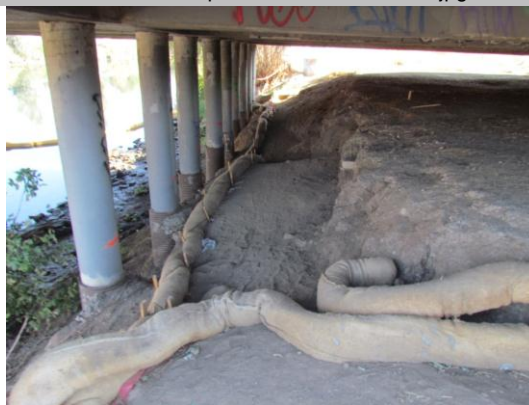
Photo 6 of 6 : pkazi_s_20140415_493.jpg

LM Start	22.52	Rating **	U	Issue No.	48 (cont)
LM End	22.52	Issue Type +	Ma	Location *	WS

View of the erosion under the I-5 bridge looking upstream.

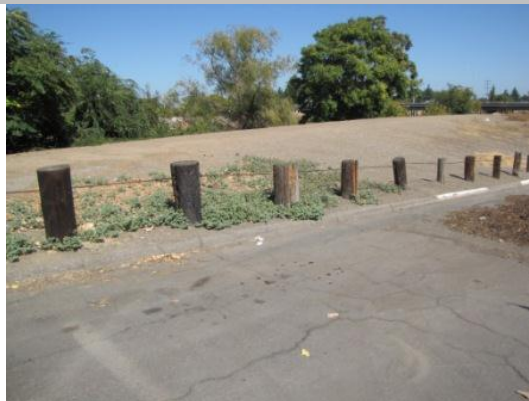
Photo 1 of 1 : pkazi_s_20140415_540.jpg

LM Start	22.52	Rating **	M	Issue No.	114
LM End	22.57	Issue Type +	En	Location *	LS
Category	Earthen Levee			GPS Latitude/Longitude	
				Start	End
Item	Encroachments			37.978464 °	37.978208 °
				-121.341620 °	-121.342190 °
DWR ID	DWR_NA0017_16_s_2012_114				
Action/Comments					
Fence

View of post and cable fence along the landward levee slope looking upstream.

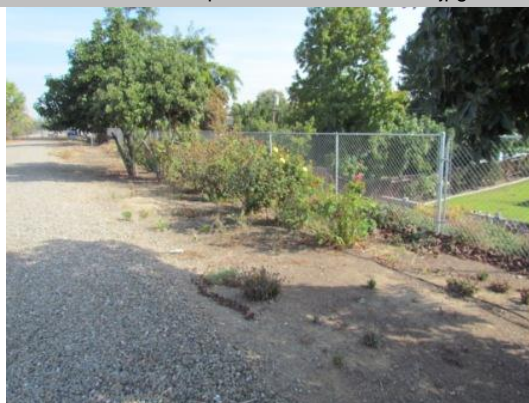
Photo 1 of 1 : pkazi_s_20140415_538.jpg

LM Start	22.58	Rating **	M	Issue No.	111
LM End	22.87	Issue Type +	En	Location *	LS
Category	Earthen Levee			GPS Latitude/Longitude	
				Start	End
Item	Vegetation			37.978078 °	37.975086 °
				-121.342523 °	-121.346027 °
DWR ID	DWR_NA0017_16_s_2012_111				
Action/Comments					
Landscaping

Landscape was found on the landside of the levee looking upstream.

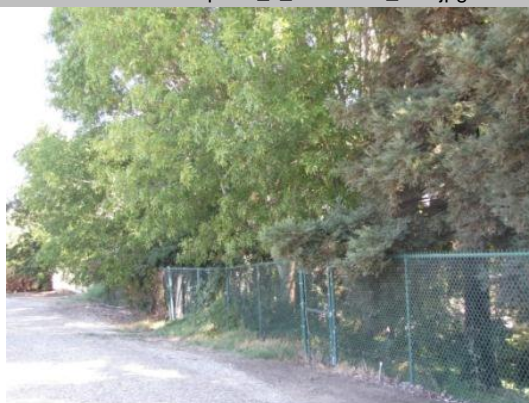
Photo 1 of 1 : pkazi_s_20140415_537.jpg

LM Start	22.58	Rating **	M	Issue No.	110
LM End	22.87	Issue Type +	En	Location *	LS
Category	Earthen Levee			GPS Latitude/Longitude	
				Start	End
Item	Encroachments			37.978081 °	37.975086 °
				-121.342519 °	-121.346027 °
DWR ID	DWR_NA0017_16_s_2012_110				
Action/Comments					
Fence

View of fence and landscaping along the landward shoulder and slope looking upstream.

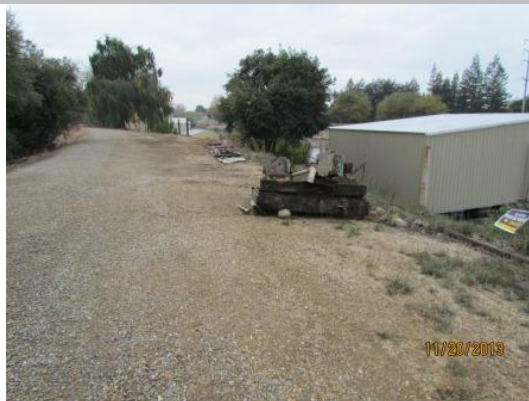
Photo 1 of 1 : pkazi_s_20140415_490.jpg

LM Start	22.76	Rating **	M	Issue No.	43
LM End	22.76	Issue Type +	Ma	Location *	WS
Category	Earthen Levee			GPS Latitude/Longitude	
				Start	End
Item	Encroachments			37.976308 °	37.976308 °
				-121.344698 °	-121.344698 °
DWR ID	DWR_NA0017_16_f_2013_43				
Action/Comments					
Debris

Debris was found on the waterside shoulder of the levee looking downstream.

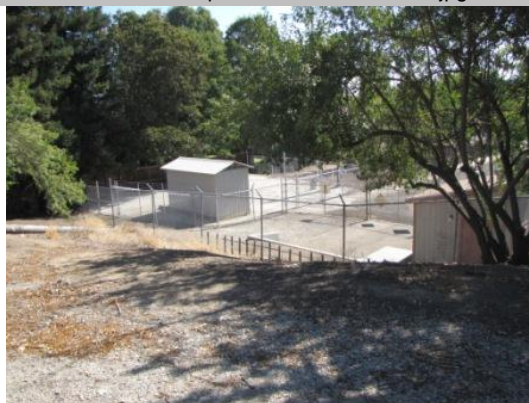
Photo 1 of 1 : pkazi_s_20140415_536.jpg

LM Start	22.87	Rating **	M	Issue No.	109
LM End	22.89	Issue Type +	En	Location *	LS
Category	Earthen Levee			GPS Latitude/Longitude	
				Start	End
Item	Encroachments			37.975087 °	37.974883 °
				-121.346027 °	-121.346298 °
DWR ID	DWR_NA0017_16_s_2012_109				
Action/Comments					
Fence

View of fence along the landward slope.

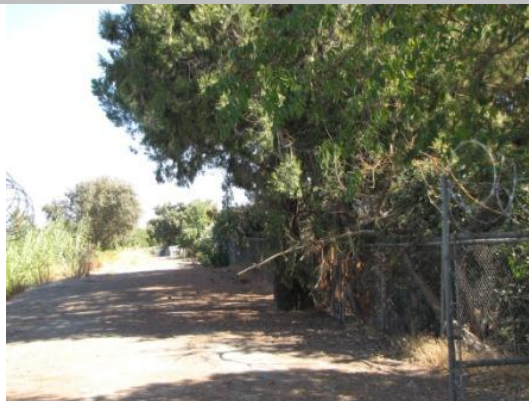
Photo 1 of 1 : pkazi_s_20140415_535.jpg

LM Start	22.90	Rating **	M	Issue No.	106
LM End	23.08	Issue Type +	En	Location *	LS
Category	Earthen Levee			GPS Latitude/Longitude	
				Start	End
Item	Encroachments			37.974869 °	37.973108 °
				-121.346317 °	-121.348820 °
DWR ID	DWR_NA0017_16_s_2012_106				
Action/Comments					
Fence

View of fence and landscaping along the landward shoulder looking upstream.

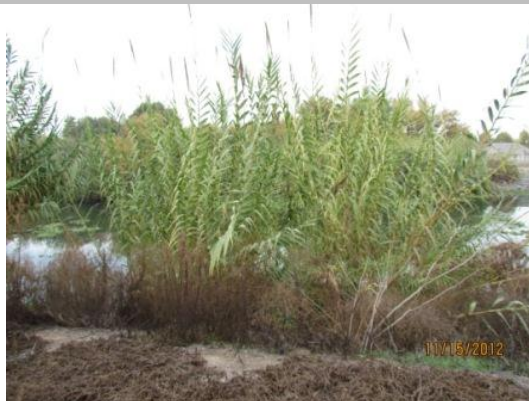
Photo 1 of 1 : pkazi_s_20140415_491.jpg

LM Start	23.05	Rating **	M	Issue No.	45
LM End	23.05	Issue Type +	Ma	Location *	WS
Category	Earthen Levee			GPS Latitude/Longitude	
				Start	End
Item	Vegetation			37.973386 °	37.973386 °
				-121.348241 °	-121.348241 °
DWR ID	DWR_NA0017_16_f_2012_45				
Action/Comments					
Remove the wild growth other than native grasses from the levee slopes.					
Inspector Comments: Arrundo on the waterside of the levee.

Arundo was found on the waterside slope of the levee looking upstream.

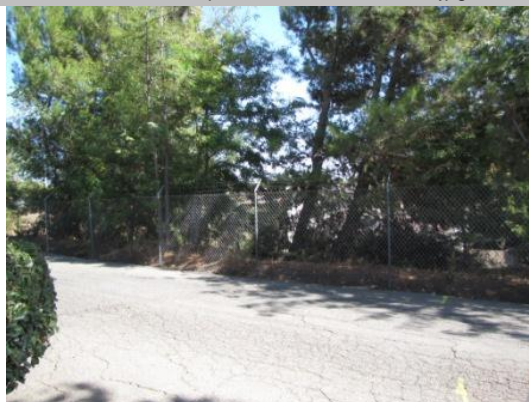
Photo 1 of 1 : pkazi_s_20140415_534.jpg

LM Start	23.08	Rating **	M	Issue No.	104
LM End	23.22	Issue Type +	En	Location *	LS
Category	Earthen Levee			GPS Latitude/Longitude	
				Start	End
Item	Encroachments			37.973094 °	37.971660 °
				-121.348809 °	-121.350233 °
DWR ID	DWR_NA0017_16_s_2012_104				
Action/Comments					
Fence

View of fence along the landward shoulder looking upstream.

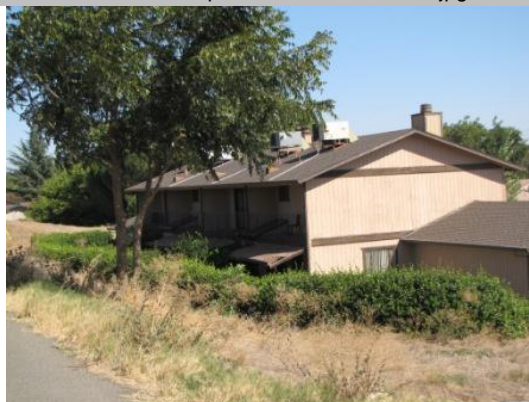
Photo 1 of 1 : pkazi_s_20140415_533.jpg

LM Start	23.24	Rating **	M	Issue No.	103
LM End	23.27	Issue Type +	En	Location *	LS
Category	Earthen Levee			GPS Latitude/Longitude	
				Start	End
Item	Vegetation			37.971257 °	37.970858 °
				-121.350300 °	-121.350450 °
DWR ID	DWR_NA0017_16_s_2012_103				
Action/Comments					
Landscaping

View of landscaping along the landward slope looking upstream.

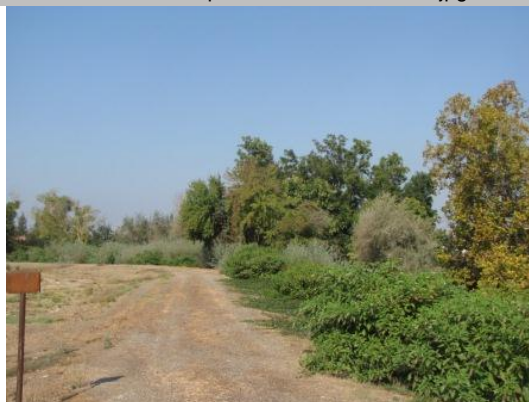
Photo 1 of 1 : pkazi_s_20140415_600.jpg

LM Start	23.70	Rating **	M	Issue No.	192
LM End	23.70	Issue Type +	En	Location *	WS
Category	Earthen Levee			GPS Latitude/Longitude	
				Start	End
Item	Encroachments			37.968392 °	37.968392 °
				-121.355721 °	-121.355721 °
DWR ID	DWR_NA0017_16_s_2012_192				
Action/Comments					
Pole

View of vegetation along the waterward slope looking downstream.

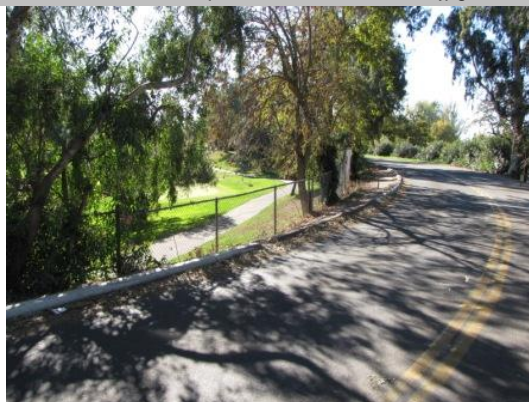
Photo 1 of 1 : pkazi_s_20140415_599.jpg

LM Start	23.70	Rating **	M	Issue No.	182
LM End	24.00	Issue Type +	En	Location *	LS
Category	Earthen Levee			GPS Latitude/Longitude	
				Start	End
Item	Encroachments			37.968438 °	37.965997 °
				-121.355882 °	-121.360479 °
DWR ID	DWR_NA0017_16_s_2012_182				
Action/Comments					
Fence					
Inspector Comments: Chainlink fence along the landward slope.

View of the fence along the landward slope looking downstream.

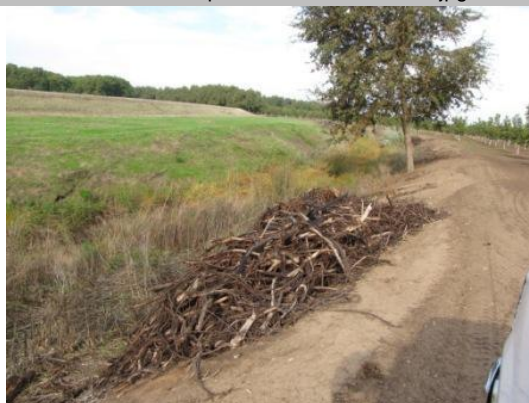
Photo 1 of 1 : pkazi_s_20140415_631.jpg

LM Start	0.13	Rating **	M	Issue No.	2
LM End	0.13	Issue Type +	Ma	Location *	WS
Category	Earthen Levee			GPS Latitude/Longitude	
				Start	End
Item	Encroachments			37.957934 °	37.957934 °
				-121.149911 °	-121.149911 °
DWR ID	DWR_NA0017_17_s_2012_2				
Action/Comments					
Prunings

View of a prunings pile along the waterward bank looking downstream.

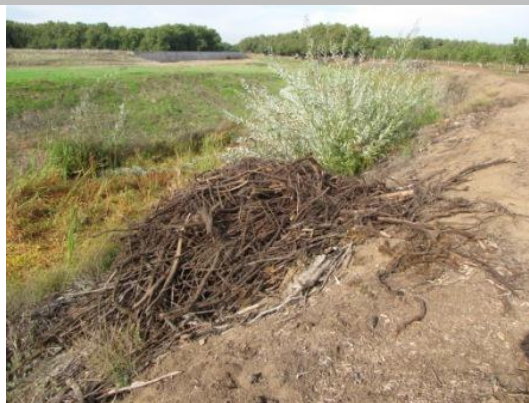
Photo 1 of 1 : pkazi_s_20140415_632.jpg

LM Start	0.17	Rating **	M	Issue No.	3
LM End	0.17	Issue Type +	Ma	Location *	WS
Category	Earthen Levee			GPS Latitude/Longitude	
				Start	End
Item	Encroachments			37.958590 °	37.958590 °
				-121.151408 °	-121.151408 °
DWR ID	DWR_NA0017_17_s_2012_3				
Action/Comments					
Prunings

View of a prunings pile along the waterward bank looking downstream.

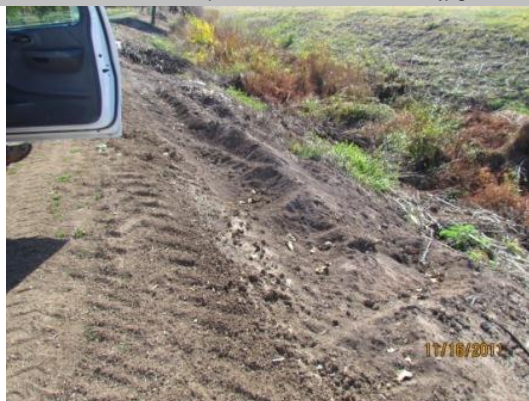
Photo 1 of 1 : pkazi_s_20140415_636.jpg

LM Start	0.19	Rating **	M	Issue No.	10
LM End	0.19	Issue Type +	Ma	Location *	WS
Category	Earthen Levee			GPS Latitude/Longitude	
				Start	End
Item	Slope Stability			37.958702 °	37.958702 °
				-121.151544 °	-121.151544 °
DWR ID	DWR_NA0017_17_s_2012_10				
Action/Comments					
Repair the levee slope damaged by vehicle traffic and prevent access where possible.

Slope instability was found on the waterside of the levee looking upstream.

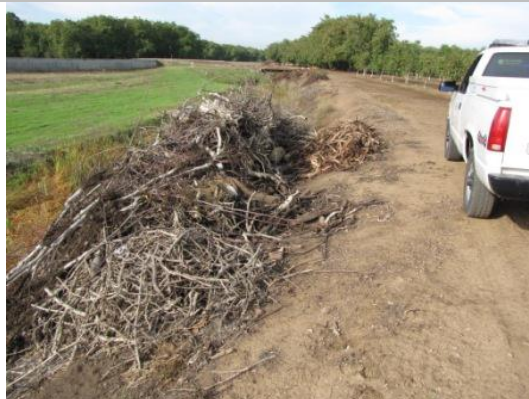
Photo 1 of 1 : pkazi_s_20140415_633.jpg

LM Start	0.22	Rating **	M	Issue No.	4
LM End	0.22	Issue Type +	Ma	Location *	WS
Category	Earthen Levee			GPS Latitude/Longitude	
				Start	End
Item	Encroachments			37.958943 °	37.958943 °
				-121.152261 °	-121.152261 °
DWR ID	DWR_NA0017_17_s_2012_4				
Action/Comments					
Prunings

View of a prunings pile along the waterward bank looking downstream.
